INTERSTATE COMMERCE COMMISSION

REPORT OF ACCIDENT ON
THE NEW ORLEANS & NORTHEASTERN
RAILROAD NEAR EASTABUCHIE,
MISS , MAY 6, 1912

BY THE CHIEF INSPECTOR OF
SAFETY APPLIANCES

REPORT OF THE CHIEF INSPECTOR OF SAFETY
APPLIANCES COVERING HIS INVESTIGATION
OF AN ACCIDENT WHICH OCCURRED ON THE
NEW ORLEANS & NORTHEASTERN RAILROAD
NEAR EASTABUCHIE, MISS. MAY 6, 1912.

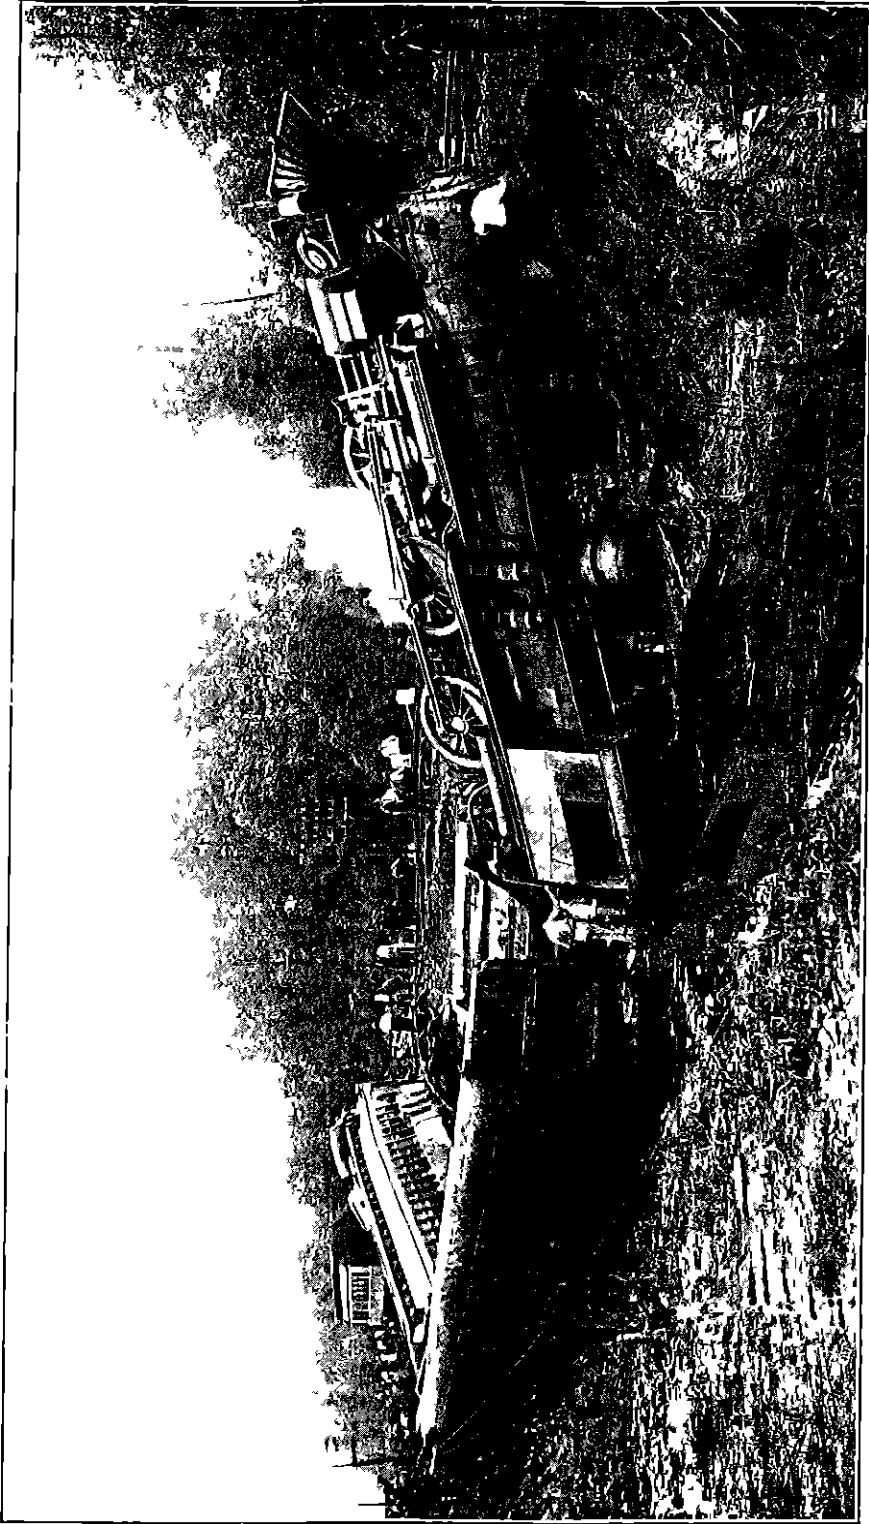
As will be seen by reference to illustration No 1 the engine and tender passed over the trestle before turning over, at a point about 180 feet north of the same. The combination baggage and passenger car turned over on its side. The second and third cars remained practically upright. No passengers were killed in any of the first three cars. The next two cars tourist sleeping cars Nos 1302 and 1161, crushed through the trestle and telescoped each other being practically destroyed. It was in these two cars that the six passengers were killed. The sixth car in the train the dining car had the forward set of trucks derailed, but escaped other damage as did the remaining five cars in the train, all of which remained on the rails.

This derailment was caused by the soft and uneven condition of the track. It is clearly shown that this track was, and had been for some time, in bad condition. It had even been necessary to repair the track twice within 10 days preceding the date of the accident while at the time of derailment the track was being reconstructed.

The first three cars of this train were of steel underframe construction and none of them was materially damaged as is shown by illustration No. 1. In illustration No. 2 the dining car is seen at the left standing on the southern end of the trestle. On the right is seen the third car of the train, the body of it being practically undam-

1 GENERAL VIEW OF DERAILMENT LOOKING SOUTH

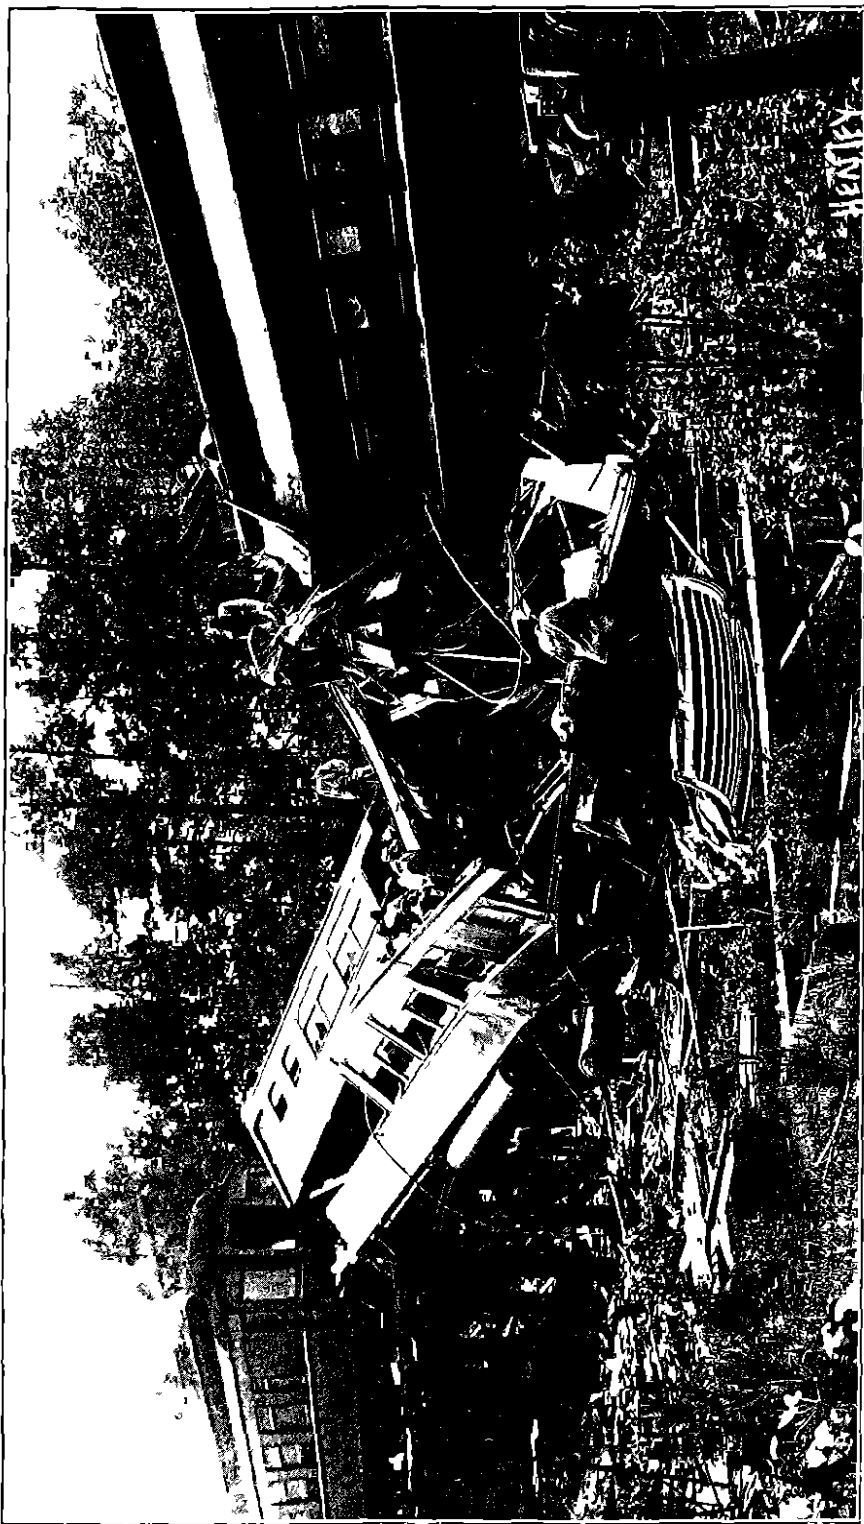
aged. Between these two cars can be seen the remnants of the two wooden tourist cars, one of which was built 26 years ago, the other 32 years ago. What happened to these two cars can not but lend emphasis to the recommendation contained in the Commission's last report to Congress that the adoption of steel cars be required. The bridge through which these cars plunged although in good condition and well maintained was not of sufficient strength to withstand the pressure to which it was subjected. Had these cars been of modern steel underframe or all-steel construction, or had the bridge been of stronger construction, the long list of casualties would undoubtedly have been greatly reduced.

2. VIEW SHOWING FRAGMENTS OF TOURIST SLEEPING CARS NOS. 1102 AND 1161
