## INTERSTATE COMMERCE COMMISSION.

### REPORT OF THE CHIEF INSPECTOR OF SAFETY APPLIANCES IN RE INVESTIGATION OF ACCIDENT ON THE PACIFIC ELECTRIC RAILWAY, NEAR LOS ANGELES, CAL, ON JULY 13, 1913.

AUGUST 6, 1913

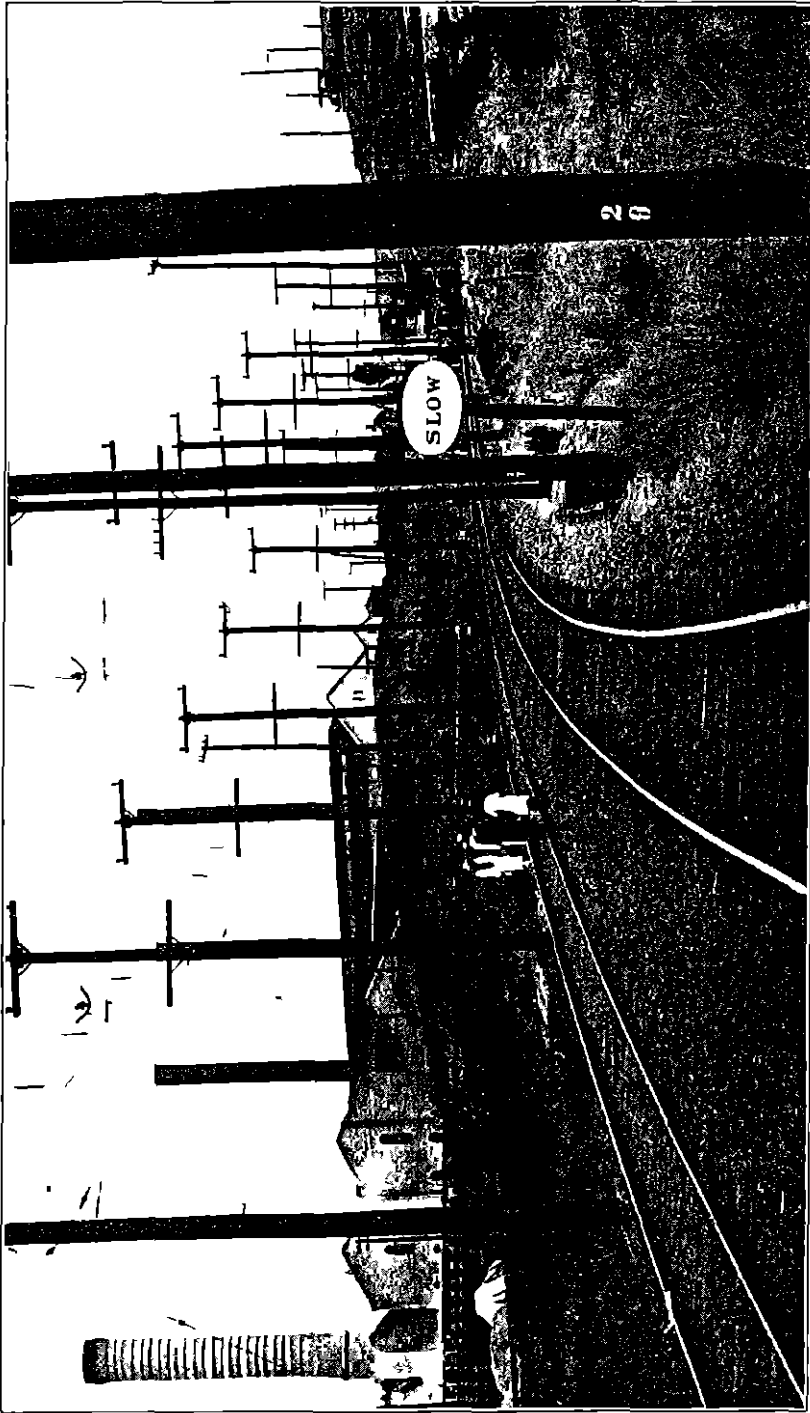
The track is straight for a distance of about 180 feet west of the point where the accident occurred, and then there is a curve of about  $2\frac{1}{2}^{\circ}$ , 639 feet in length, diverging toward the south. A slow board is located on this curve, 609 feet from the point where the collision occurred and 1,000 feet from the junction at Vineyard. Approaching from the west the view of the track at the point of collision was obstructed by the bank of a cut and by poles lining the track.

General view of track approaching scene of accident, showing slow board, bank of cut, and trolley poles along the track.

In this case it is believed that the flagman did not go back the required distance, the evidence indicating that he had not reached the slow board which was only 609 feet from the rear end of the standing train, and although he had both fusees and torpedoes with him he did not use either.

Had the motorman of extra 874 observed the speed restriction in effect at this point the accident probably would have been averted, in spite of short flagging. The evidence indicates that the speed of the train when it passed the slow board was in excess of 30 miles per hour and it was undoubtedly more than 10 miles per hour when the collision occurred. On July 16 tests were made with a train of three cars of the 800 class to determine the distance within which a train of this character could be brought to a stop. During these tests there were about 30 people in the train, and the speed in each case was 41 miles per hour. In the first test the current was shut off at the slow board and immediately a 10-pound reduction was made, resulting in a service application of the brakes, and the train was brought to a full stop in 425 feet. In the second test an emergency application of the brakes was made at the slow board and the train was brought to a full stop in 400 feet. As a result of these tests, it is believed that had the motorman of extra 874 applied the brakes at the slow board the train would have been stopped in time to avert the collision, the distance between the slow board and the point where the accident occurred being sufficient to allow for the greater distance required for stopping the loaded train as compared with the train used in these tests.
