INTERSTATE COMMERCE COMMISSION

REPORT OF THE CHIEF OF THE DIVISION OF SAFETY COVERING THE INVESTIGATION OF AN ACCIDENT ON THE SOUTHERN RAILWAY NEAR TUXEDO, N C, ON AUGUST 12, 1914

FEBRUARY 8, 1915

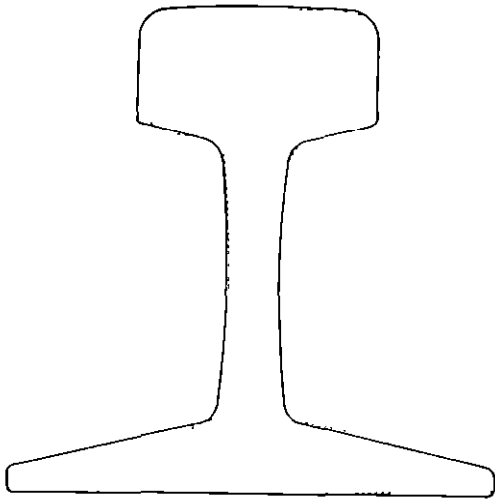
Amount of flange wear indicated by dotted lines

The fractured rail had experienced considerable flange wear, as shown by the accompanying sketch, where the full lines of the drawing represent the original cross section, according to the dimensions prescribed for the A S C E, 85-pound section, while the present worn shape is shown by dotted lines.

The metal which had been lost by abrasion and wear amounted to about 0.38 square inch, chiefly flange wear, and from the gauge side of the running surface of the head. This abrasive loss was due to the outward thrusts of the wheel flanges, incident to its position on the outside of a sharp curve.

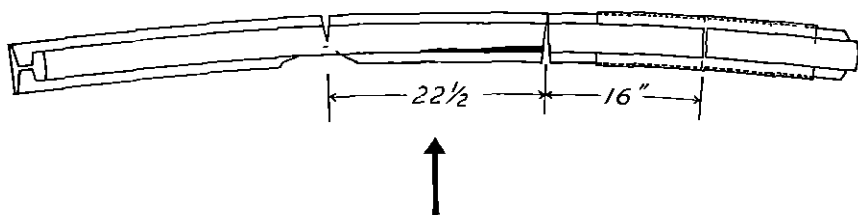
The progressive manner in which the rail broke, as indicated by the fragments, is illustrated on the accompanying sketch.

A force was evidently exerted in the direction of the arrow, putting the outside flange of the rail into a state of tension, and causing the initial line of rupture to have its point of inception at the edge of the outer flange. A crescent shaped piece was detached from the inner flange of the base on the compression side of the bend. The general direction of travel of this line of rupture was from outside toward the inside of the rail.

After the rail was broken in one place, it would then present a short overhanging end attached by the splice bars to the rail next beyond. The force continuing to act on this short end would next develop a fracture starting from the inside face of the rail, extending to the outside. This was the direction taken by the secondary line of rupture, as shown by the evidence on the fragments.

A partial shearing of the head of fragment 2 occurred on the gauge side, indicated by the heavy line on the sketch. One wheel

The arrow is placed on the sketch for the purpose of indicating the direction of the lateral force with respect to the rail, but will not be taken to signify that it was a horizontal force. The failure of the rail is not attributed to a direct horizontal thrust, but to its overturning by reason of that horizontal thrust, followed by the weight of the engine breaking the rail. The case would be an unusual one if the rail was fractured in an upright position, due to augmented tension of the outside flange from centrifugal forces. The evidence gathered does not lead to the latter explanation, but to the former one, that the rail first turned and was then fractured when partly or completely on its side. The transverse tests, which showed greatly diminished resistance when the rail was loaded on its side against the normal direction of loading, favor the probability of its rupture when on its side.
