# INTERSTATE COMMERCE COMMISSION

## REPORT OF THE CHIEF OF THE DIVISION OF SAFETY, COVERING THE INVESTIGATION OF AN ACCIDENT WHICH OCCURRED ON THE KANSAS CITY SOUTHERN RAILWAY NEAR AIR LINE JUNCTION, MO , ON OCTOBER 19, 1914

NOVEMBER 9, 1914

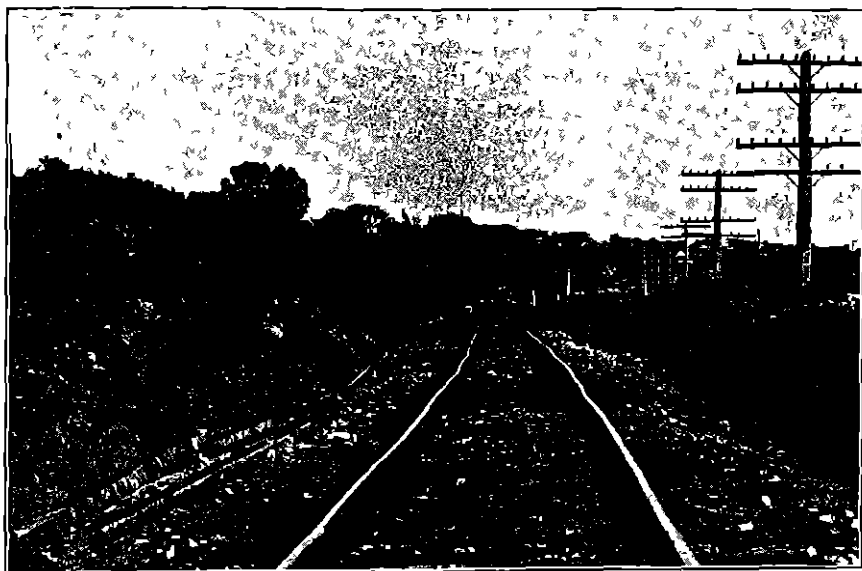
Examination of the track showed that the wheels of the locomotive had dropped down inside of the outer rail of the curve, due to the spreading of the inside rail. There were flange marks on the inside of the webs of the next two rails, which indicated that these rails had turned over, the locomotive running along on the webs. At this

No 1—View of track approaching point of derailment from the north

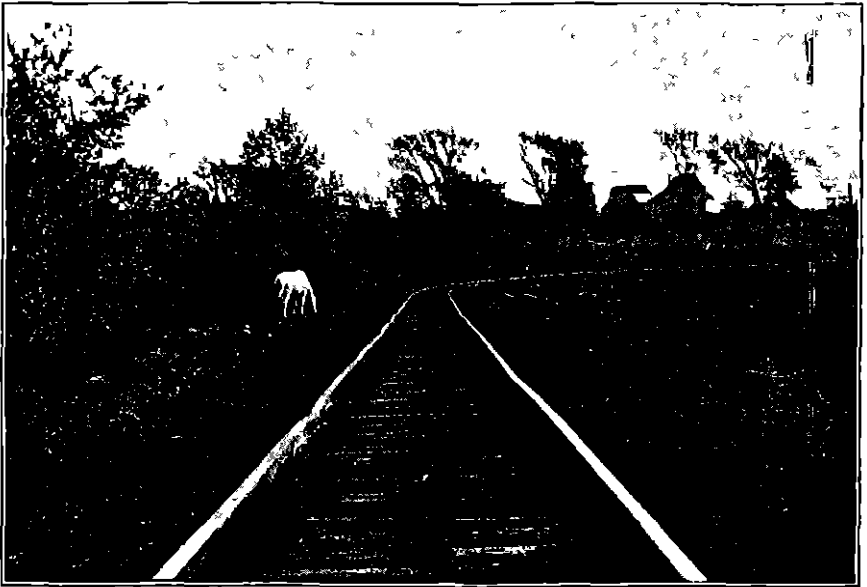
The track for a distance of one-half mile on each side of the point of derailment was found to be in bad condition, and in many instances the gauge was tight at the rail joints while at the centers the rails were spread outward. In some of these cases the gauge at the joints was 4 feet 8 inches, while at the centers it was 4 feet 9 $\frac{1}{4}$  inches. This condition is shown in illustration No 1, a view taken from the north, looking toward the point of the accident. Illustration No 2 shows a similar condition existing south of the point of derailment. Two rails were found with crescent-shaped breaks in the flange on the inside, one 6 inches in length and one 11 inches in length. About 50

No 2—View of track south of point of accident

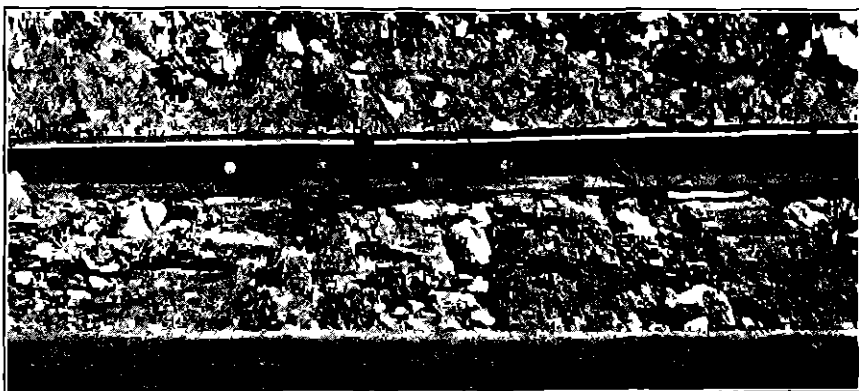
angle bars were found having only one or two bolts in them, this condition being due to the fact that some of the rails had no bolt holes drilled in them, while others were so badly matched that the holes in the angle bars did not register with the holes in the ends of the rails. Illustration No 3 shows the use of a broken angle bar at a rail joint, while illustrations Nos 4 and 5 show the use of angle bars in cases where no bolt holes were drilled in the rails, or the bolt holes in the rails did not match with the holes in the angle bars. Twenty-five angle bars were found in this mile of track which were broken or badly sheared, while in some cases there were spaces of as much as 2 inches between the ends of the rails.

No 3—Use of broken angle bar at joint
